2016 GOLD CIRCLE AWARDS ENTRY

CASTRO ROOFING'S MASTERPIECE  
SMU OWEN ARTS CENTER

Official project name: *SMU Owens Arts Center*

Modified Bitumen Roof System

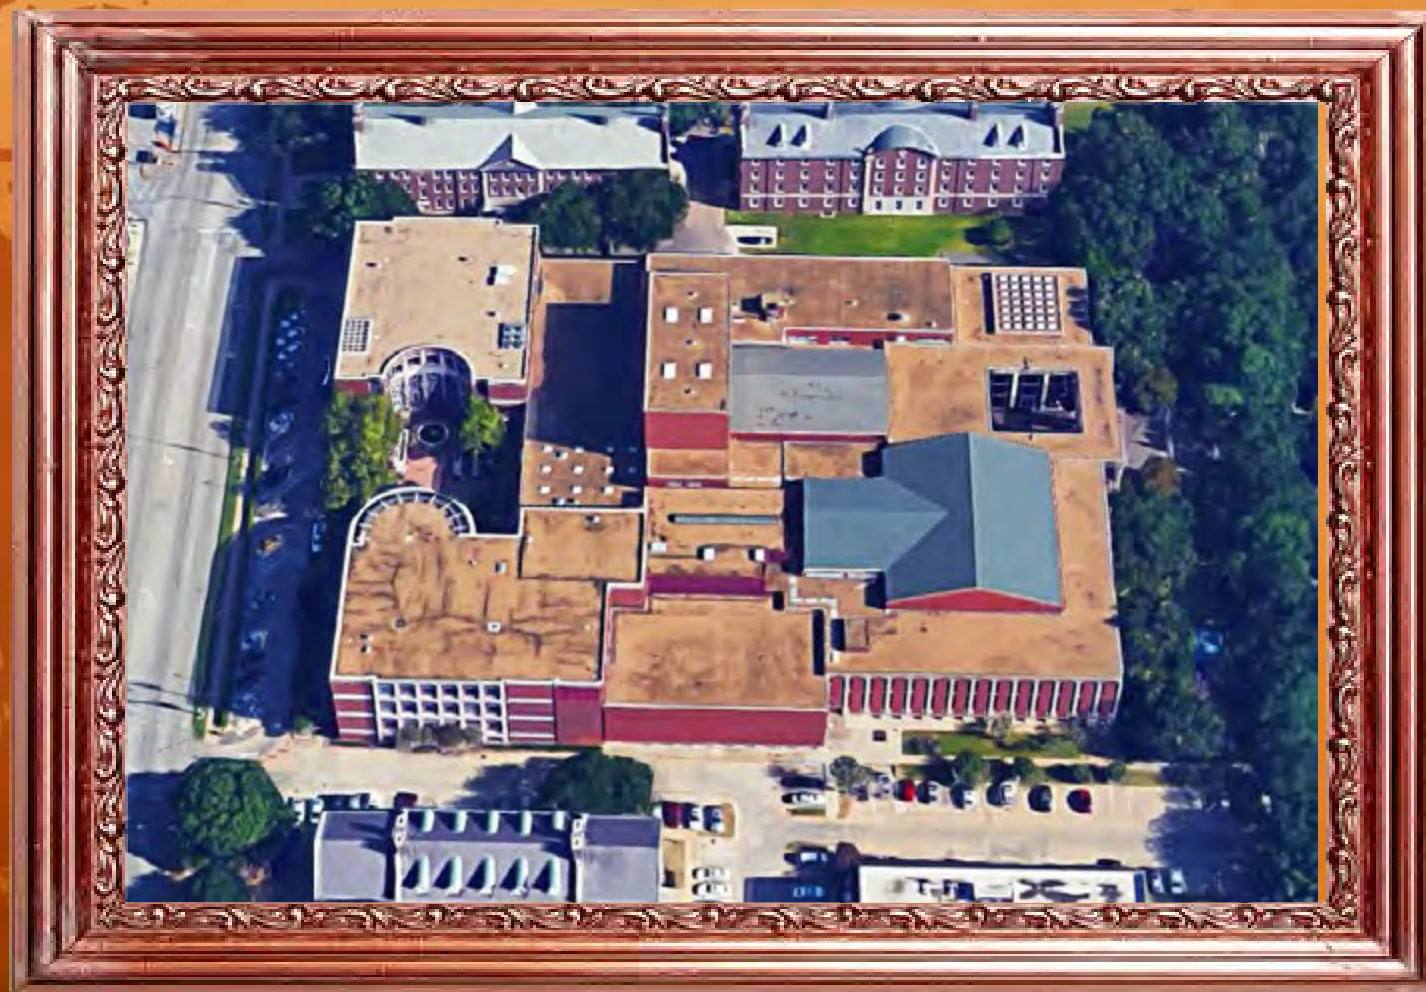
*Before Re-roof  
Existing coal tar pitch*

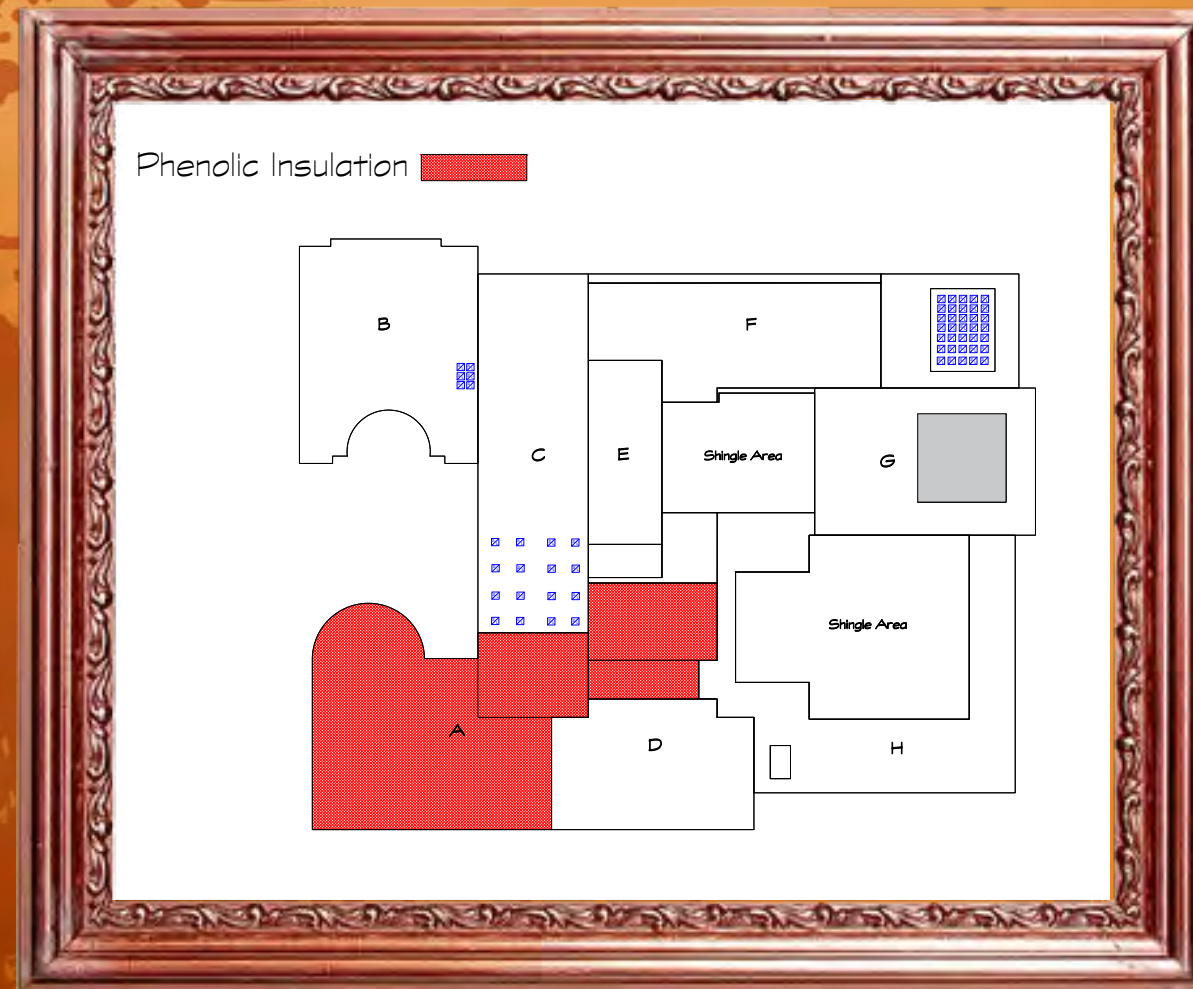
Multiple metal deck areas contained phenolic insulation, a very corrosive insulation when wet that can easily cause catastrophic metal deck failure. Fortunately the metal deck areas with phenolic were painted decks and not galvanized therefore no discernible damage was identified at these areas at the time of tear-off activities.

*Phenolic insulation location*

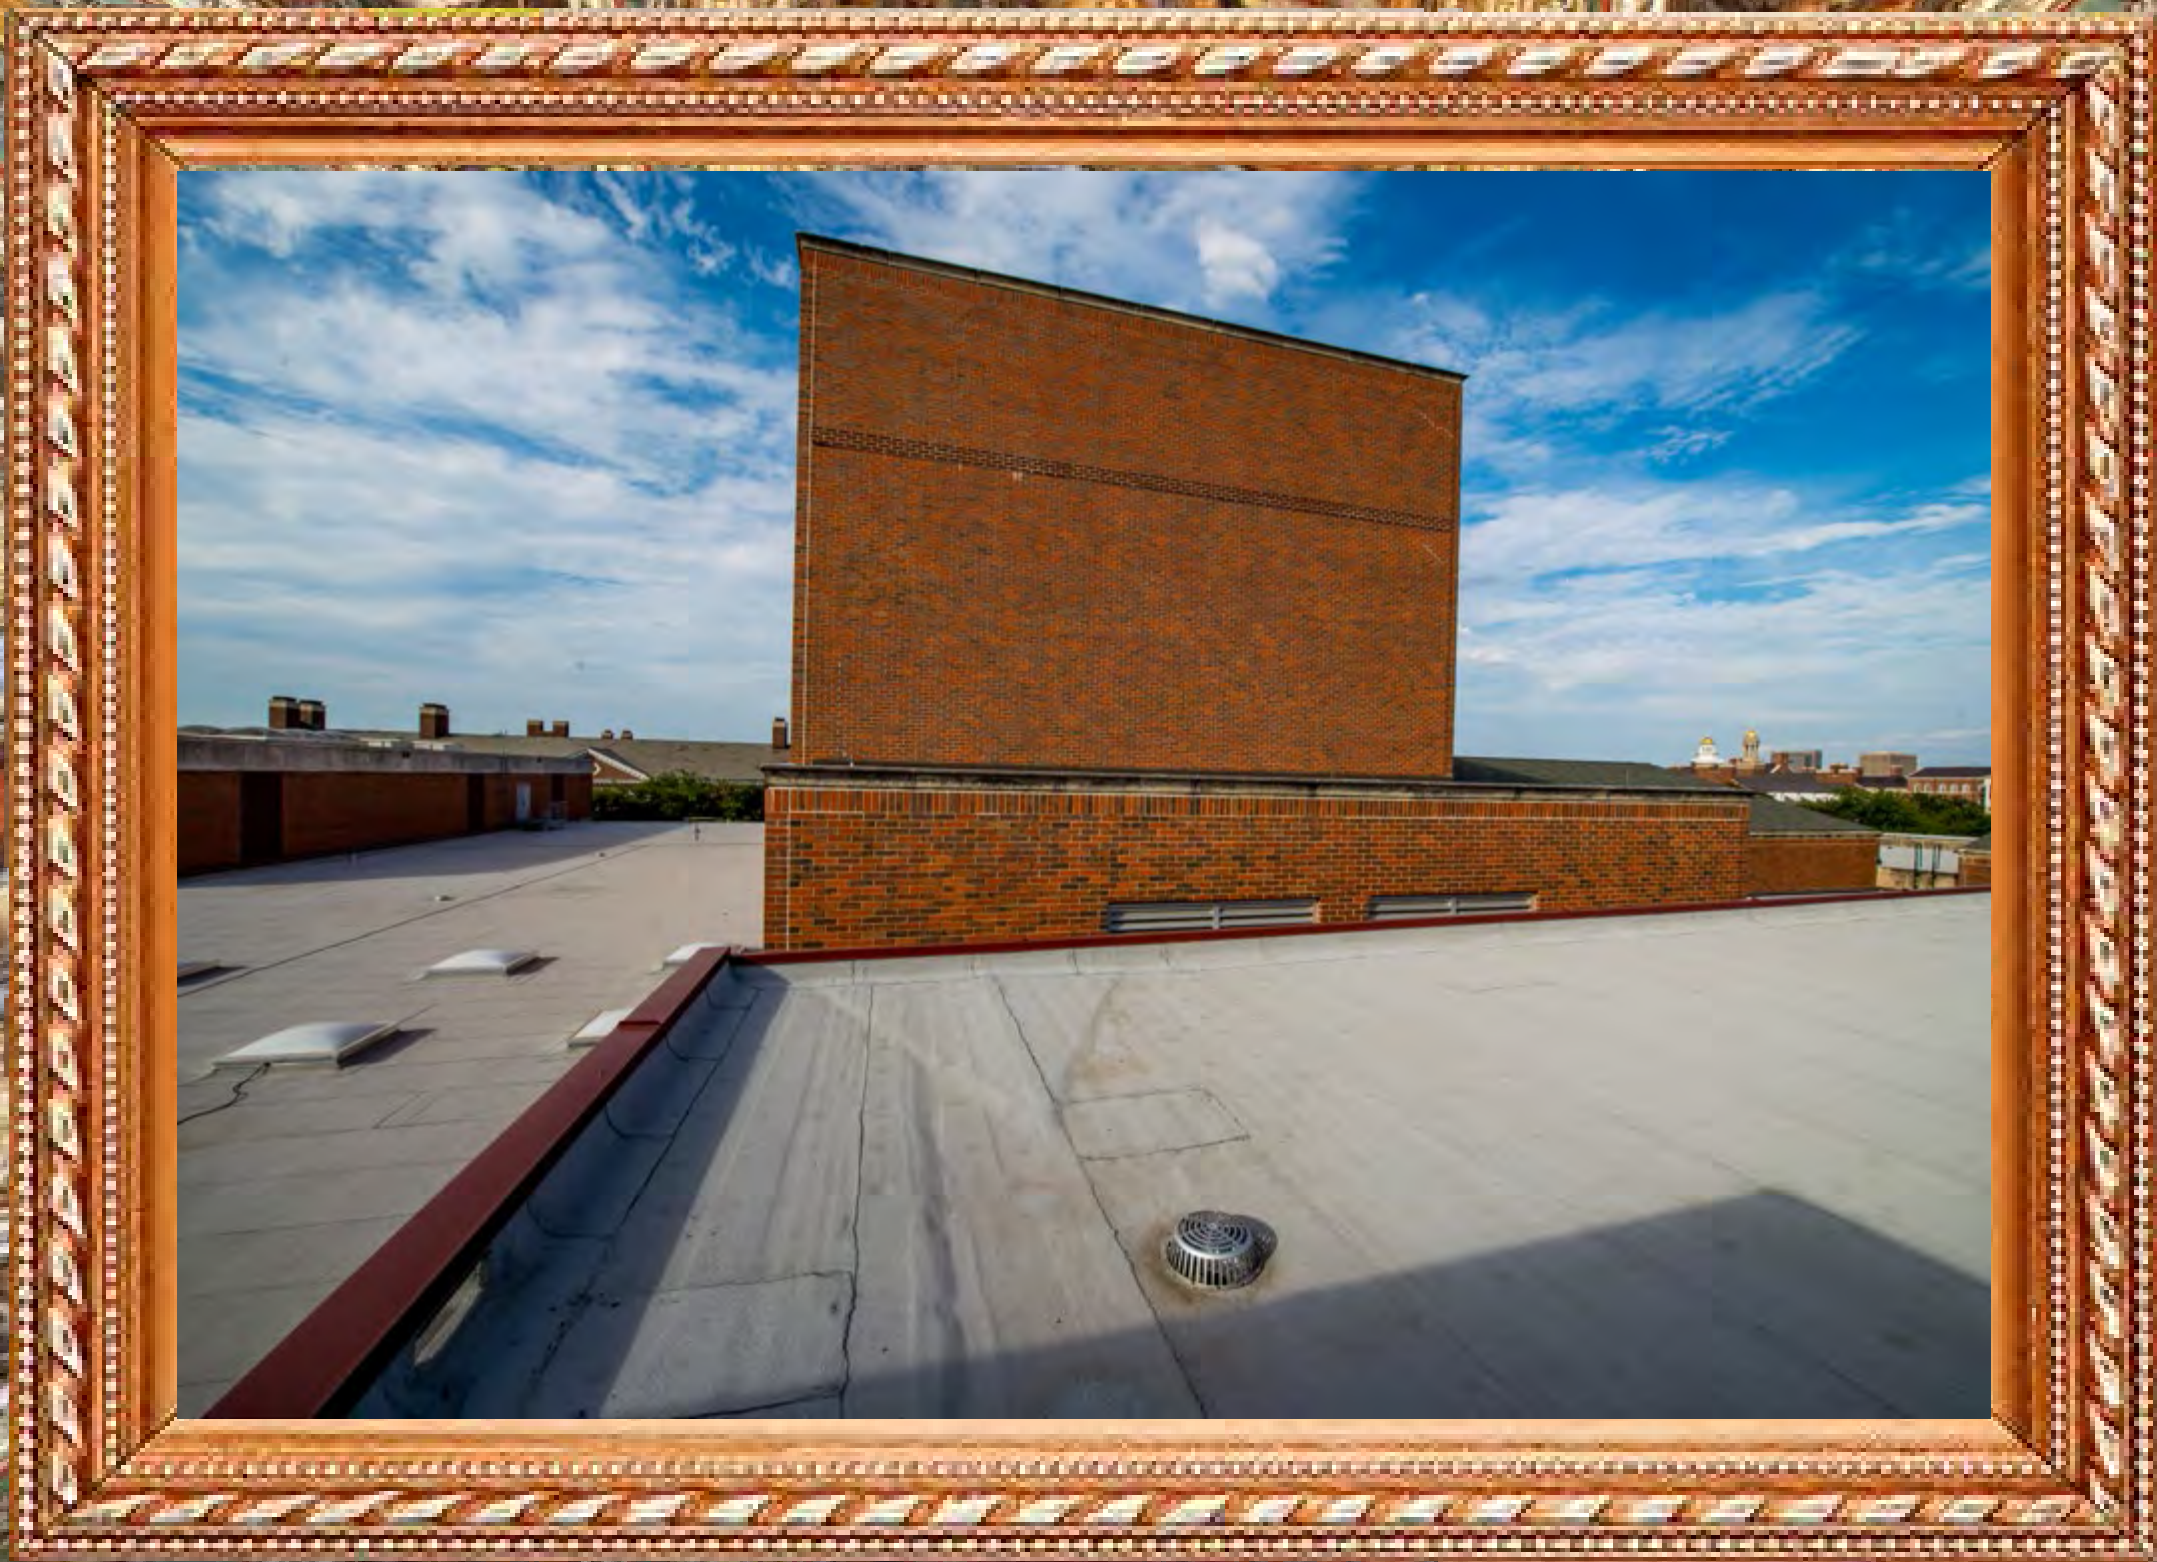
*This area could not be reached by crane (located in the middle of the roof). A chute was constructed to lower all debris down to a lower level and from there carried to the one debris lowering site. A very long ladder was also used from roof level to roof level to reach this area as there was no interior access via roof hatch. A hoist was used to raise the needed materials to this high roof area.*

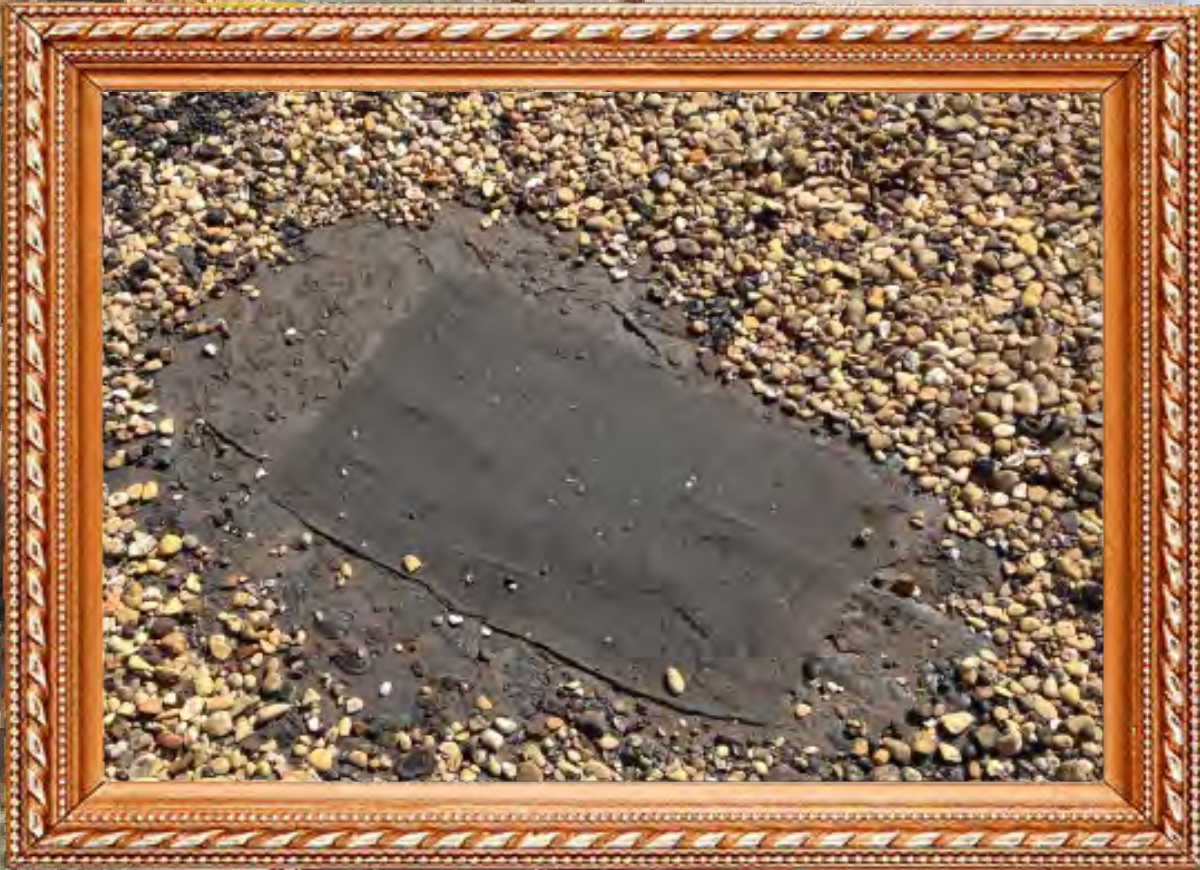
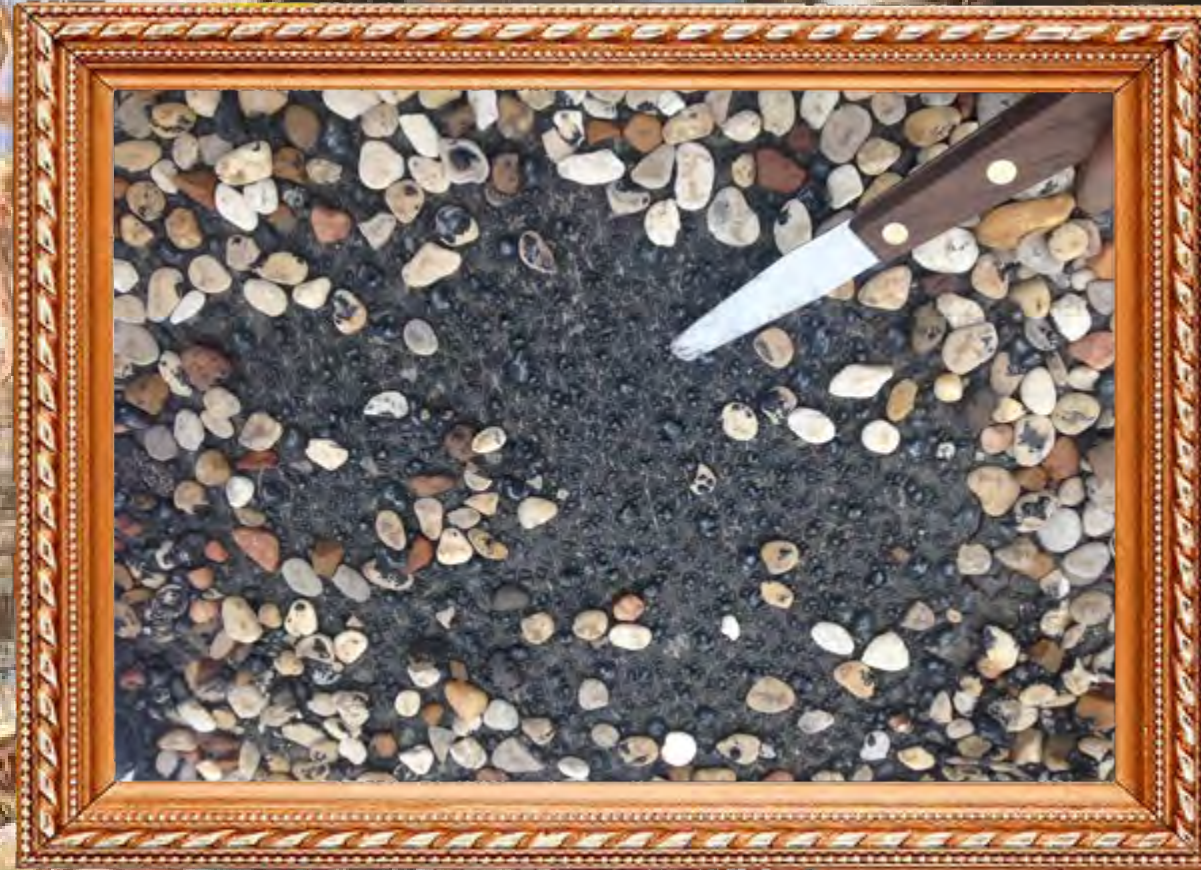
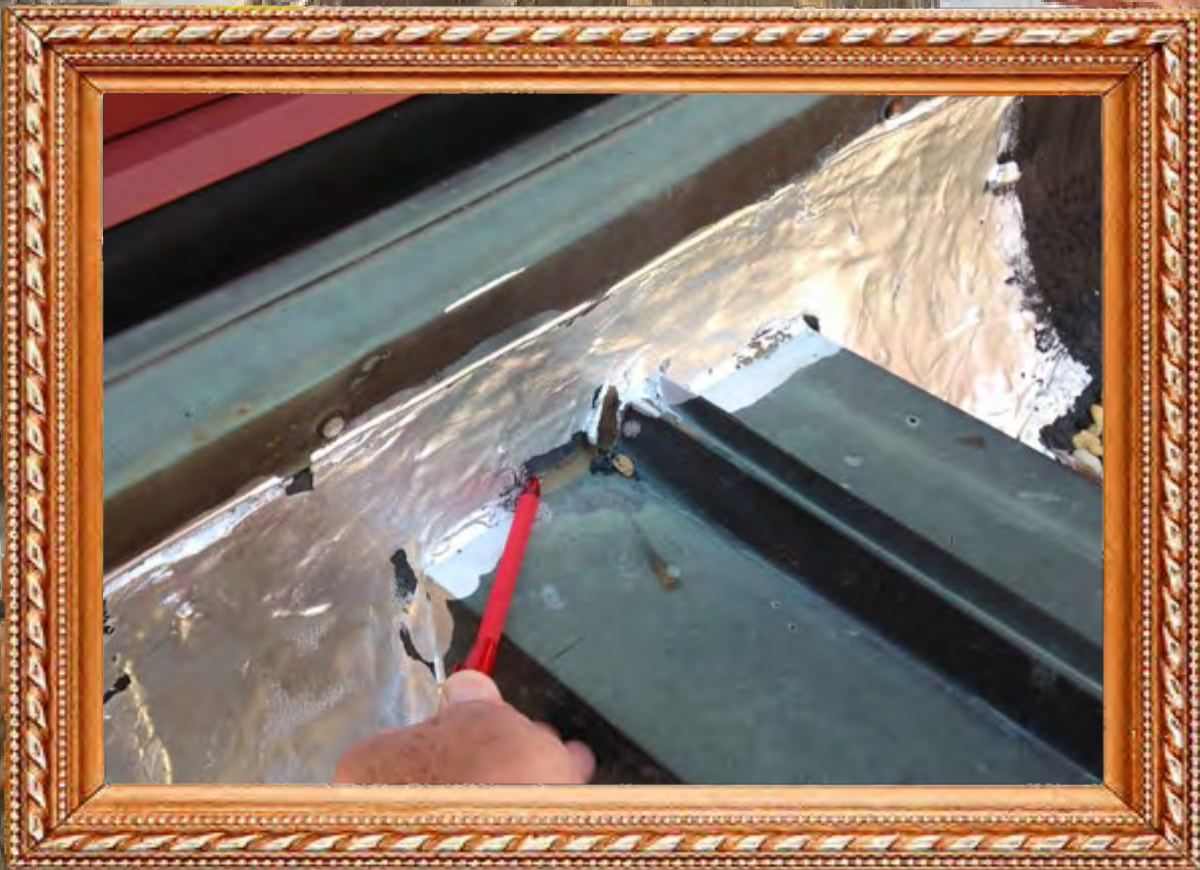
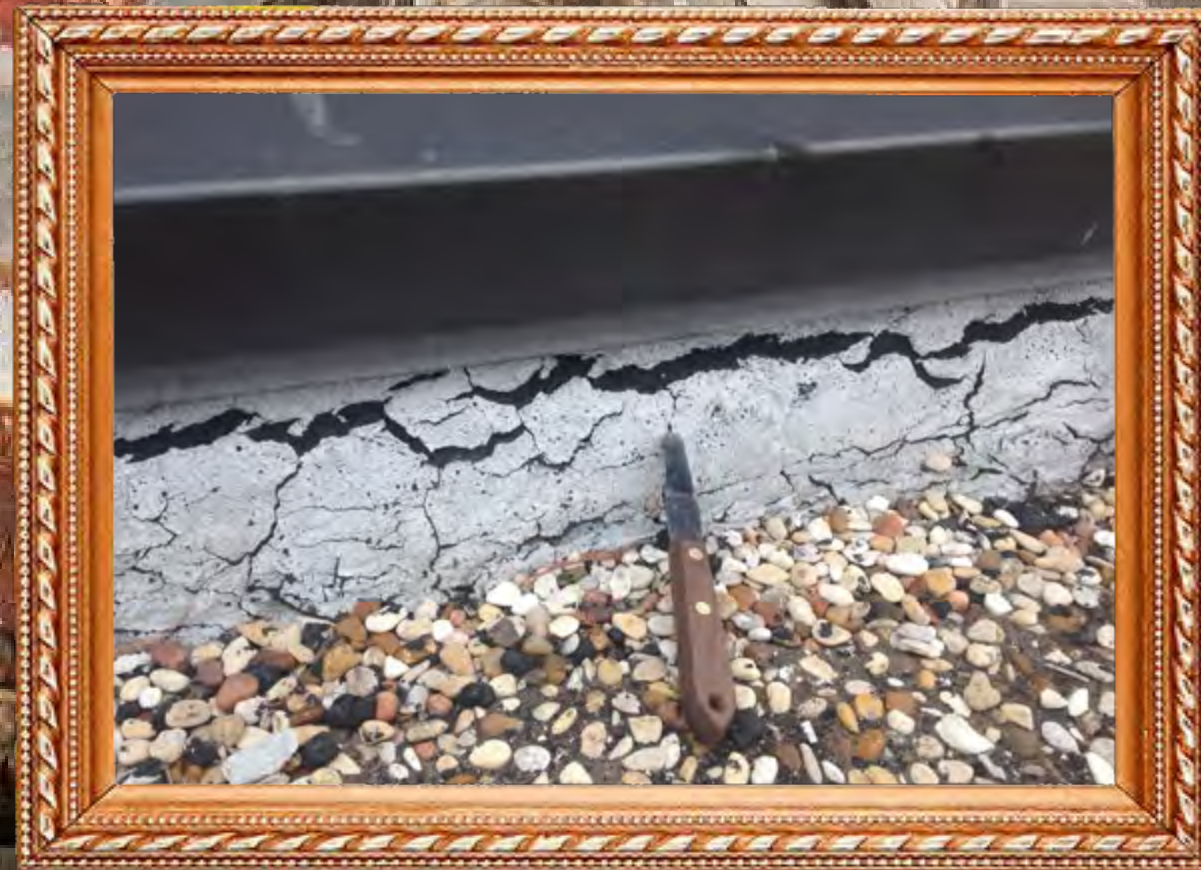
*Existing coal tar pitch roof was improperly repaired causing pre-mature roof system failure*

Coal Tar built-up roofing systems are considered the Mercedes of commercial roofing systems. The Coal Tar Pitch roof at Owen Art Center still had plenty of life left, but due to leak repairs being done incorrectly by other roofing contractors (using asphalt materials, leaving the felts exposed to the sun and not repairing the roof leaks) throughout its history caused the roof to fail prematurely.
