CASTRO ROOFING
EMPOWERING BUILDING OWNERS

ROOFSCOPE™ Report

Inspection Date: 03/05/2021

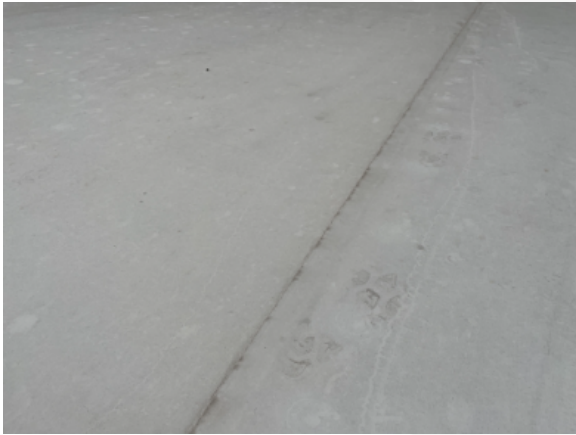
TPO Roof (No core taken)

No core was taken due to age and condition.

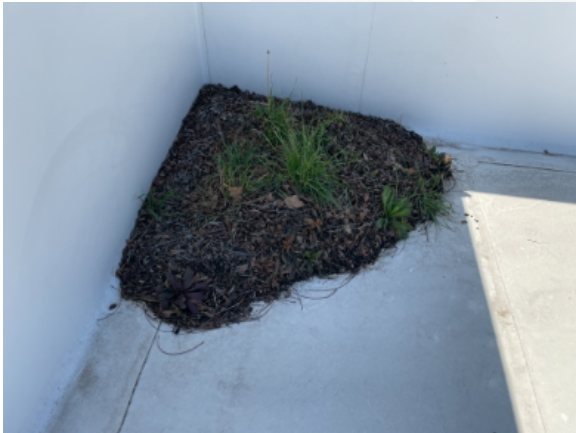
Debris facilitating organic growth in all 4 corners

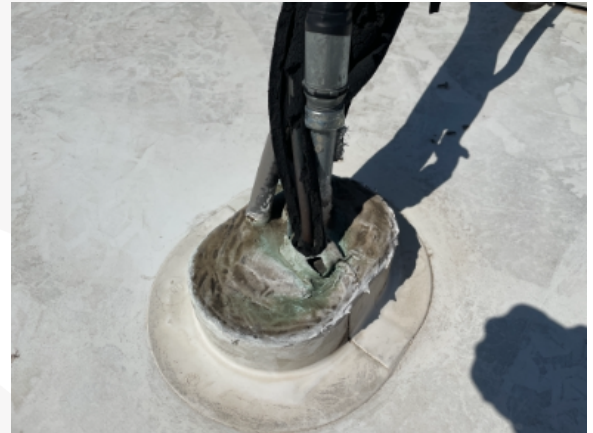
Aging pitch pans

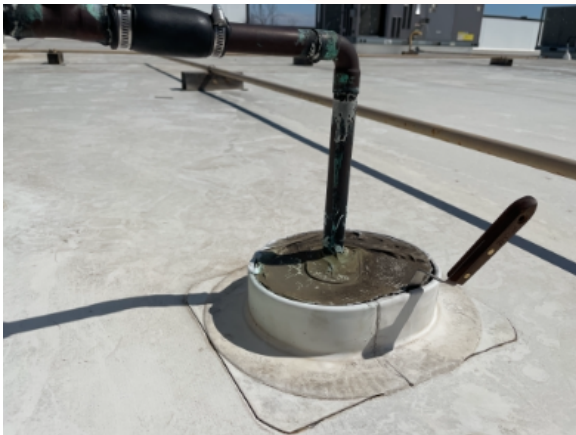
General view of pitch pan with voids

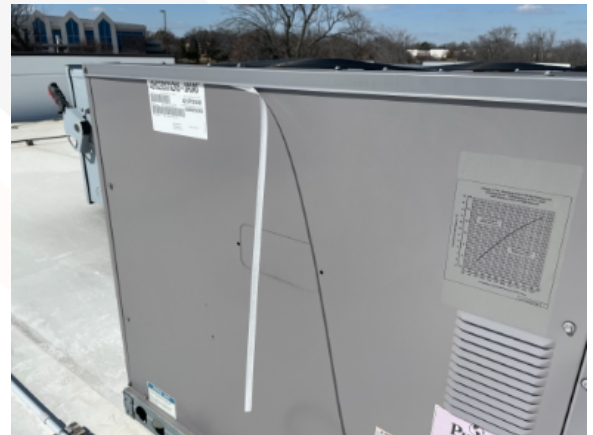
A few of the HVAC units may have some potential seal issues.

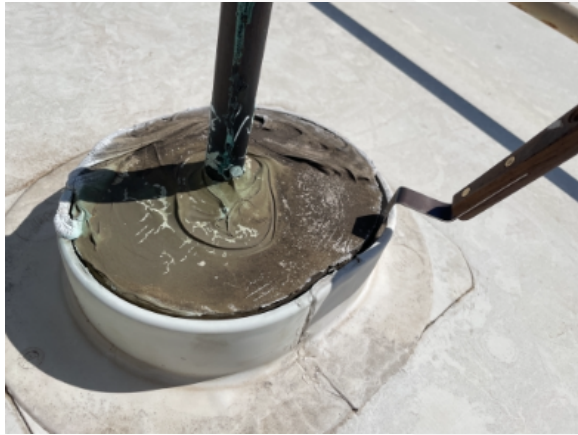
Pitch pan (Emergency)

There are several pitch pans that have failing sealant. This is allowing water into the roof which saturates the insulation and reduces the ability to keep the building cool, which causes the HVAC system to work harder and decreases efficiency, costing more money in utility bills and decreasing the HVAC unit life in the long run. Visible signs of water penetration do not tend to show up for quite a while at these locations.

Reseal the pitch pans with a urethane based product that has high tensile strength and is very flexible.

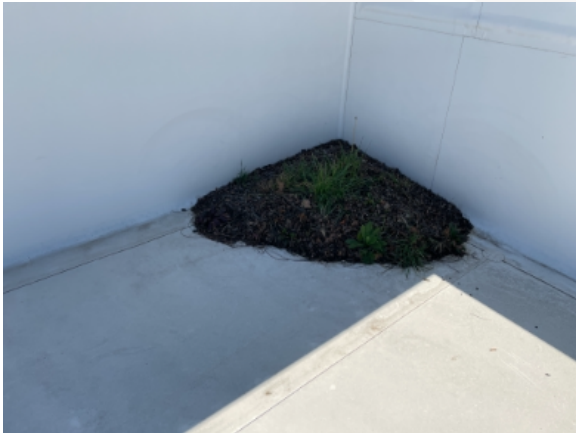
Debris can cause damage to the roof by blowing across the membrane and causing rips and punctures. In this case, most of the debris is organic. When organic material sits on roofs, it collects moisture which degrades the roof system - it also starts growing plants whose roots can cause damage as well.

Debris of any kind can also impede water flow off the roof causing many problems.

We will remove the organic material from the corners and remove other debris from the remainder of the roof

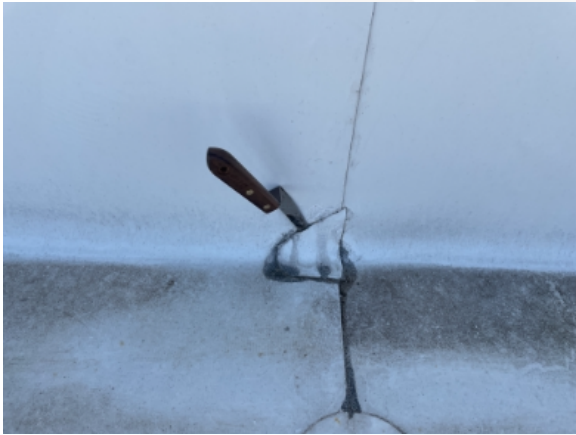
Open seam (Emergency)

This seam is open and may be allowing water into the roof, it needs to be repaired quickly.

Clean area and heat weld a TPO patch over the open seam.

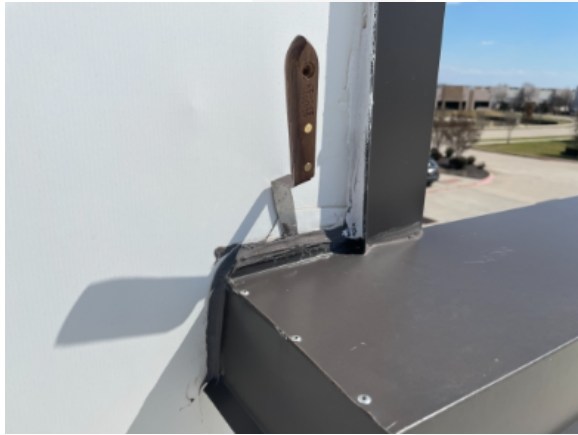
Failed sealant (Emergency)

The sealant at the coping around the roof is showing signs of severe aging. While all of these areas may not be leaking now (some of them very likely are based on inspection), they will start leaking in the future and the sealant will have to be replaced. If we repair this now, there won't be any damages done by water, if we wait until it fails, there may be water damage.

Remove the sealant, clean the area and apply new sealant.
