UNIVERSITY OF HOUSTON SCIENCE CENTER

2010
NTRCA GOLDEN HAMMER AWARD

OUTSTANDING COMMERCIAL ROOFING PROJECT

NAME OF PROJECT _____ Science Center

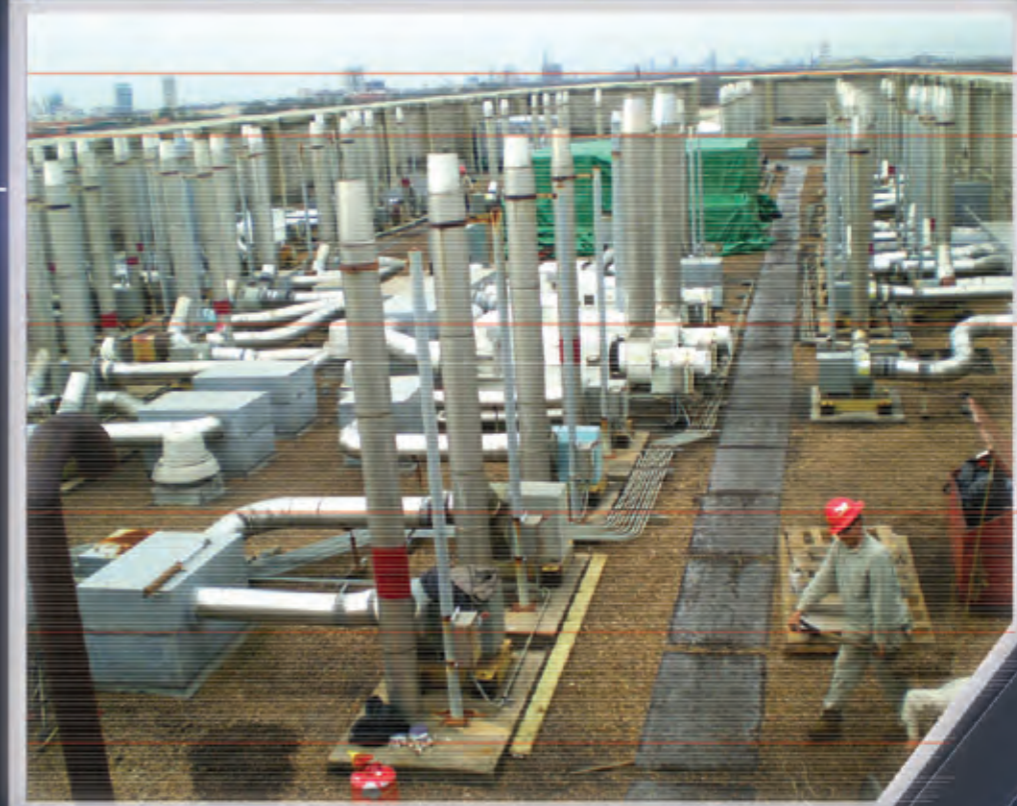
This is the old BUR System prior to removal.

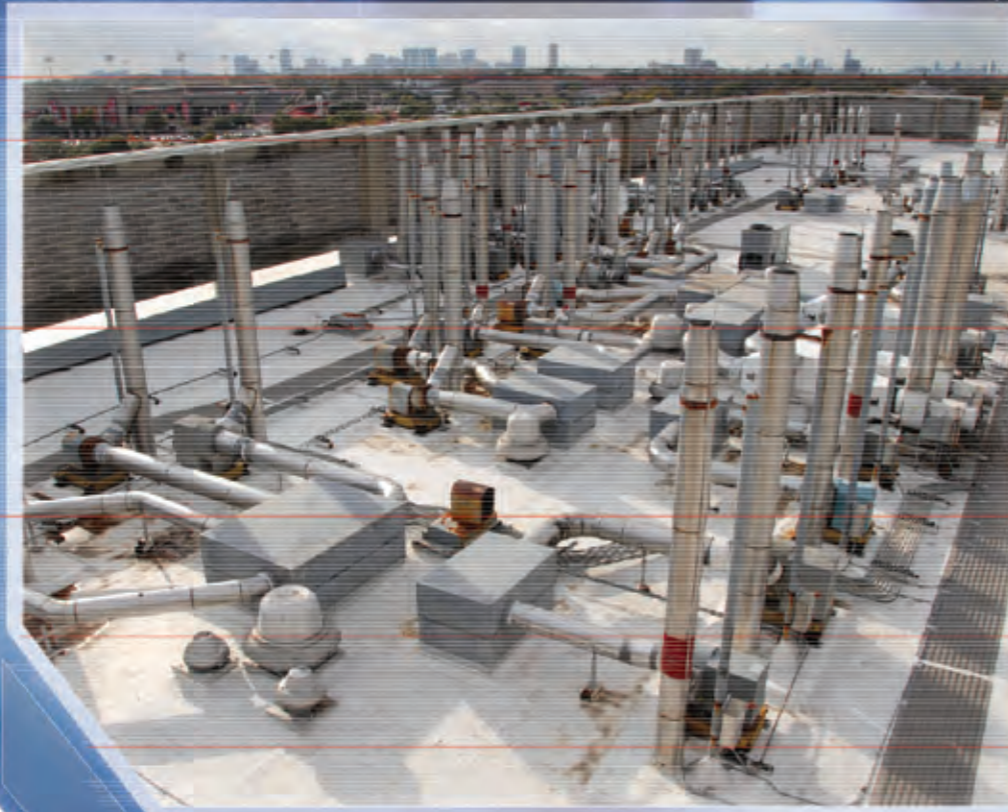
New Energy Star Roof

This is the completed roof after the installation of the new high performance energy star roof system, including new walkway protection, sheet metal flashing, reworked electrical conduits and repositioned the lightning protection system.

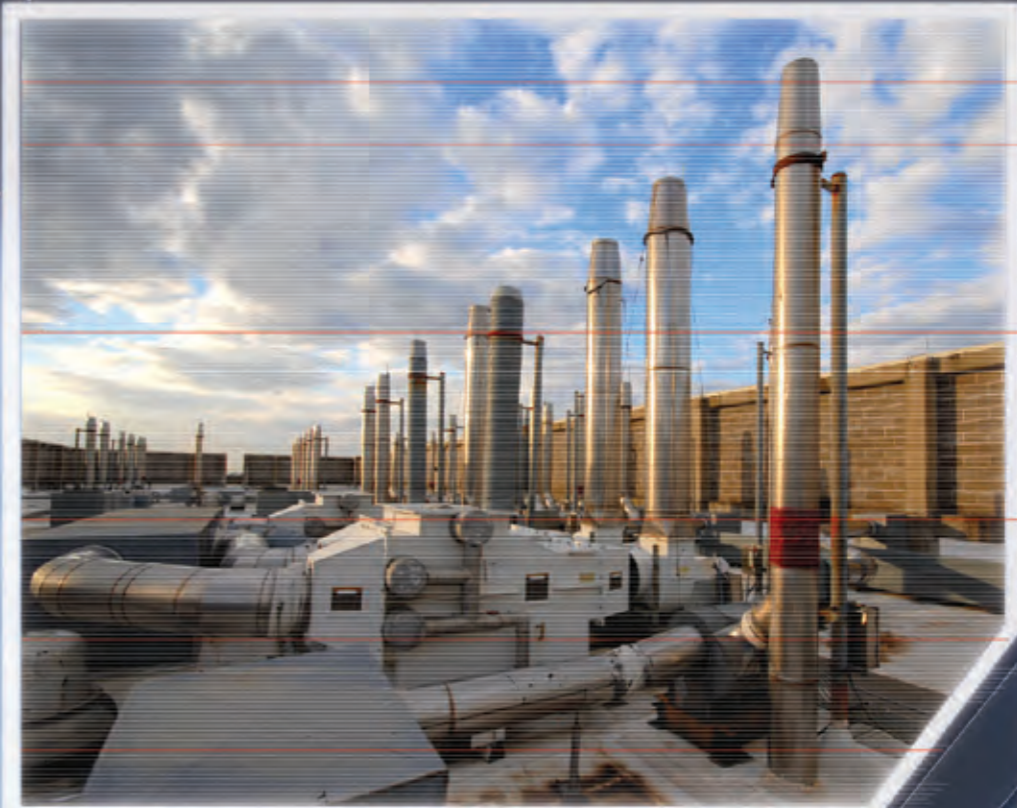
No Disconnection of Power

The majority of the units had to be lifted 1 inch from the roof's surface to enable the roof membrane to be installed underneath them.

This task had to be accomplished without disconnecting the electrical power, conduits or ductwork on the building.

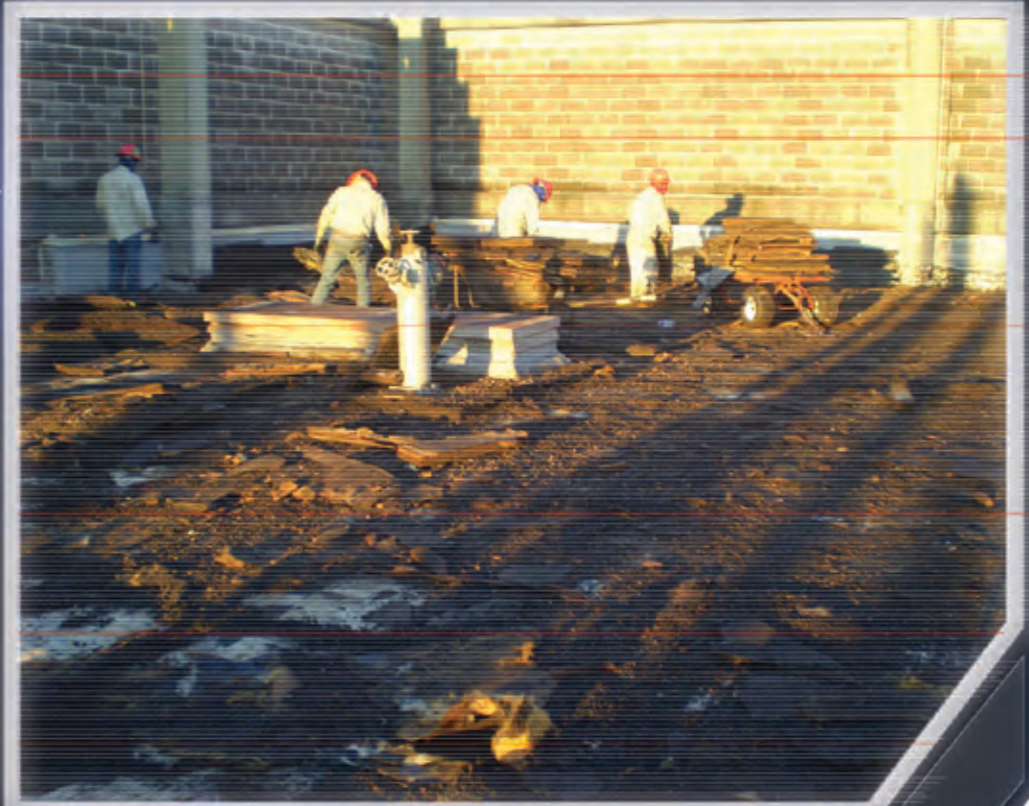
Over The High Wall

Workers removing the existing roof had to move all roof debris to a single location to be lifted up over the wall then down to the ground for disposal.

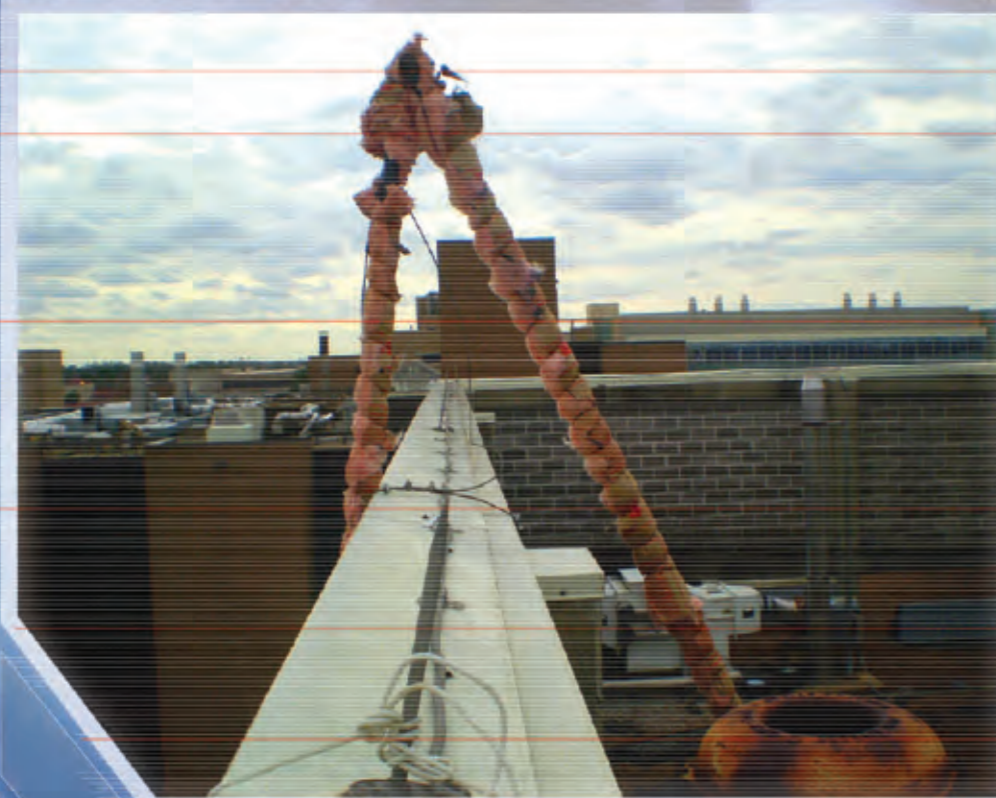
100 FT. Climb

This pipe pumps hot asphalt 100 feet up the building then 16 feet down onto the roof. The pipes were insulated to keep the asphalt from cooling and clogging inside the pipe.

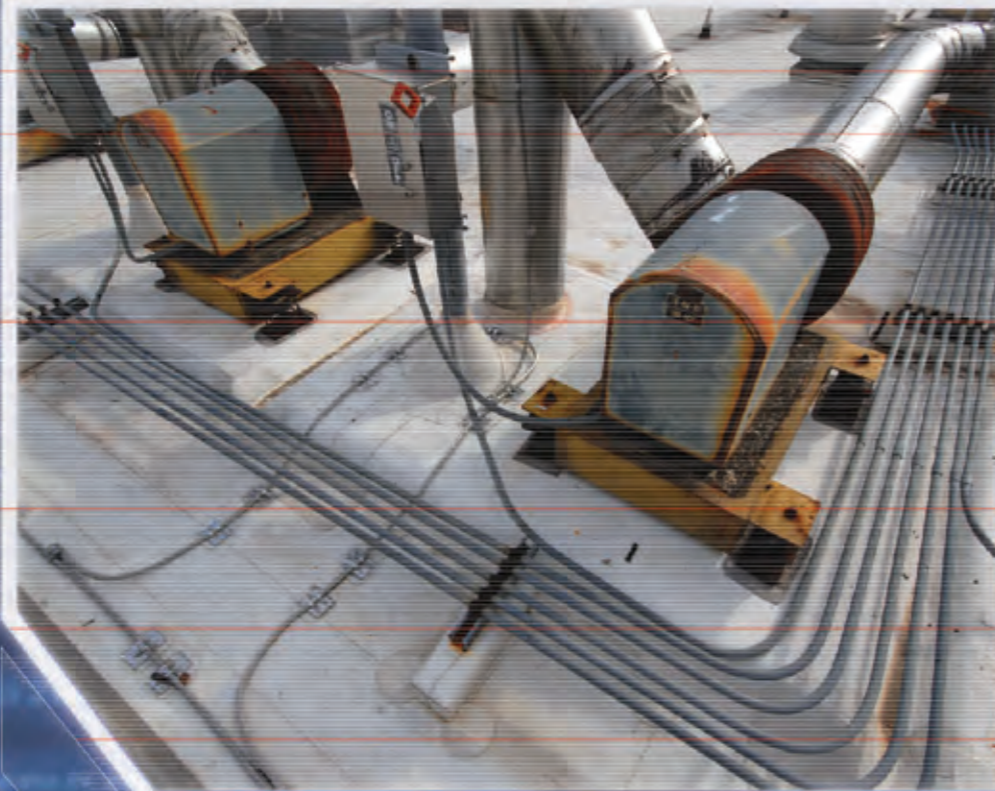
14,400 FT. of Electrical Conduit

14,400 feet of electrical conduit had to be raised to remove the existing roof system without disconnection of power. The new roof system had to be carefully installed underneath the electrical conduit. After the roof was completed, the conduit had to be repositioned with the new conduit supports and new protection pads.

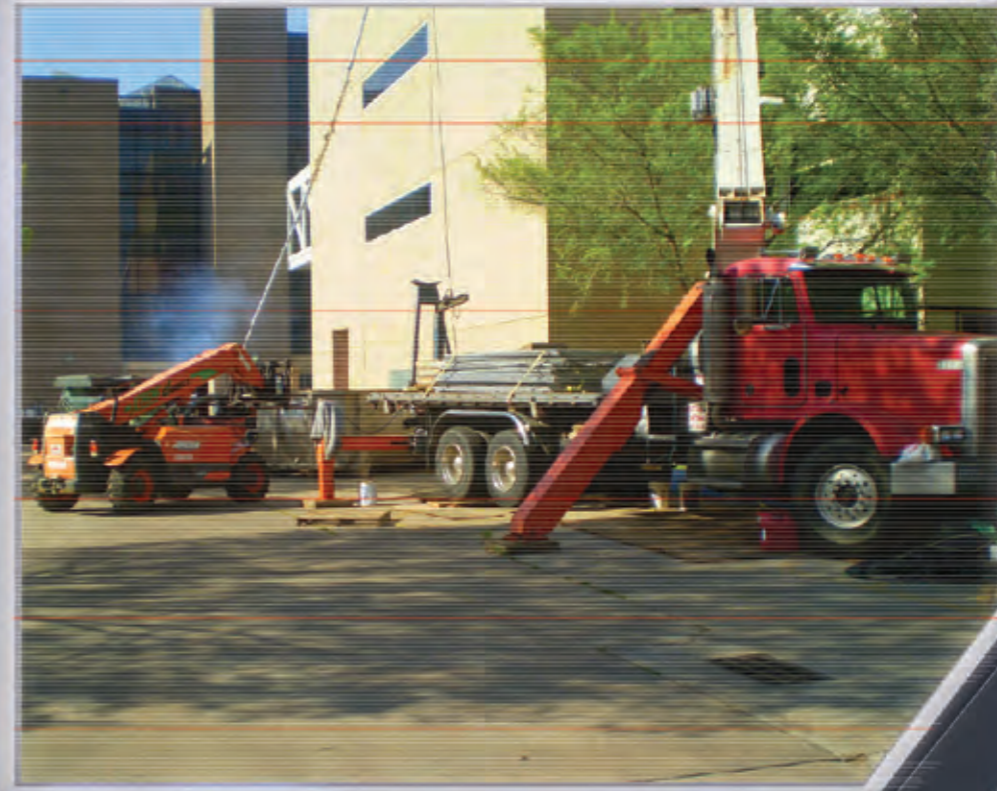
Confined Set-up Area

The pumping of the hot asphalt up to the top of the building was restricted to only one location on the roof. A set of special safety precautions were taken to prevent pedestrian injury.

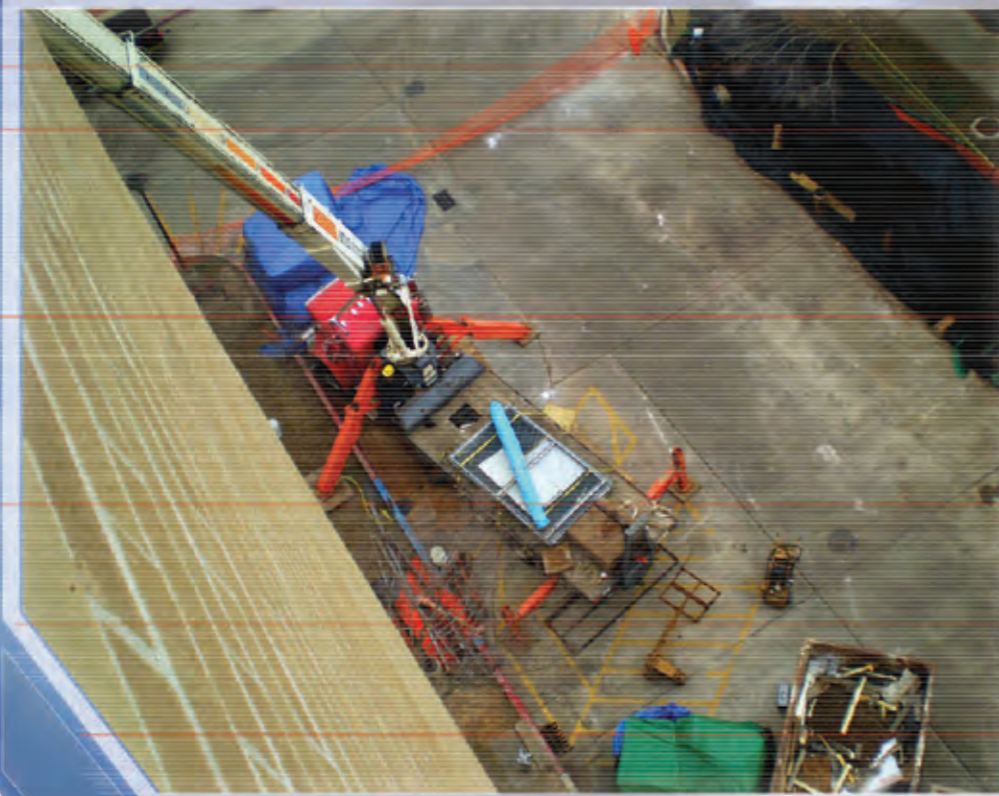
A View From Above

The working access area was limited to one location for lowering roof debris and raising materials. Access to the loading dock had to be open at all times for other vendors to use.
