Professional Roofing Professional Roofing and a stry

Castro Roofing of Texas becomes a part of history at the Hall of State in Dallas

"We considered it a privilege to be chosen as the roofing contractor for this building of heroes," says Project name: Hall of State

Roof system type: Cold-applied SBS polymer-modified

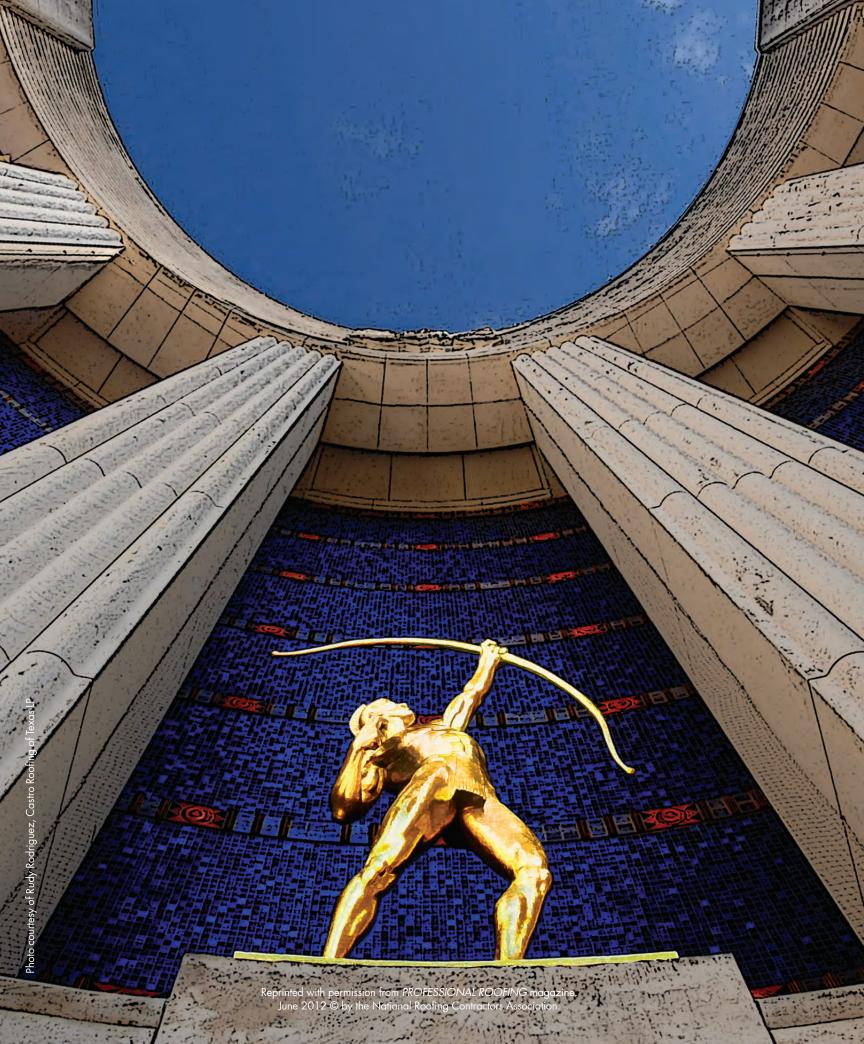
Pictured counterclockwise from top right: removal of roof system components; tear-off of existing built-up roof system; aerial view of Hall of State; attaching PermaPly 28 fiberglass base felt with UltraLok Locking fasteners; and finishing details on existing fan curb

In March 2011, Castro Roofing of Texas removed the existing built-up roof system down to the gypsum deck. The 14-man crew then mechanically attached Johns Manville's PermaPly® 28 fiberglass base felt with UltraLok™ Locking Impact Fasteners. A fully tapered insulation system at select areas was applied with urethane adhesive and 2.8-inch-thick polyisocyanurate insulation boards and ½-inch-thick DuraBoard™ was secured with urethane adhesive. Finally, a DynaBase® SBS polymer-modified bitumen sheet and DynaKap™ fire-resistant elastomeric polymer-modified bitumen cap sheet was applied with MBR® Cold Application Adhesive.
