ARTFULLY EXECUTED ROOFING

CASTRO ROOFING RENOVATES MULTIPLE ROOF SYSTEMS ON THE OWEN ARTS CENTER IN DALLAS

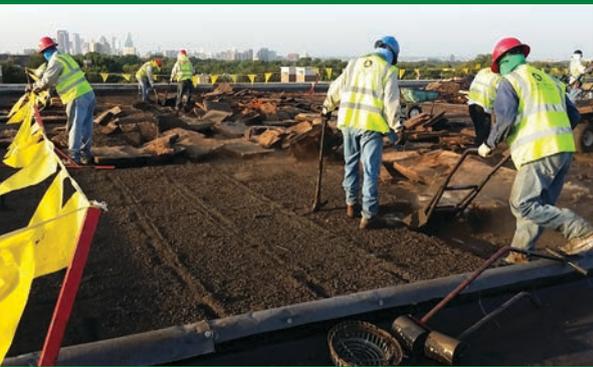
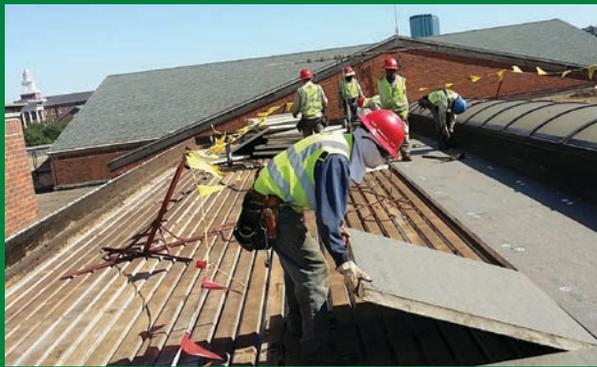
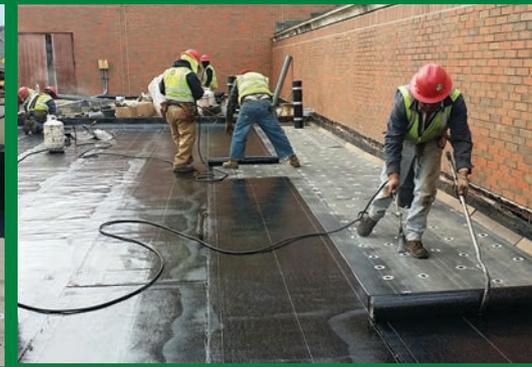
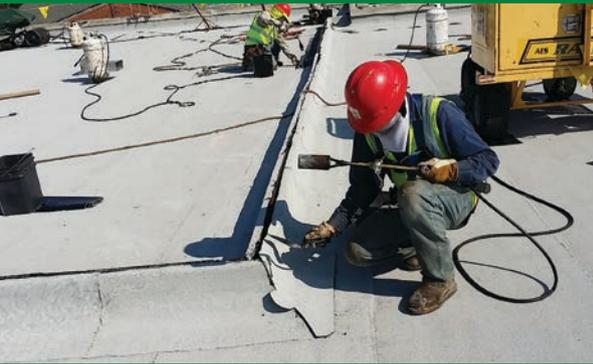
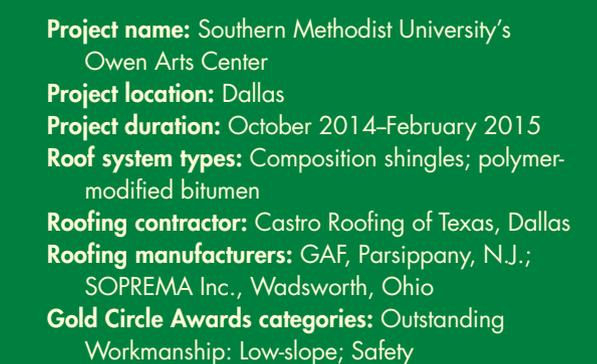
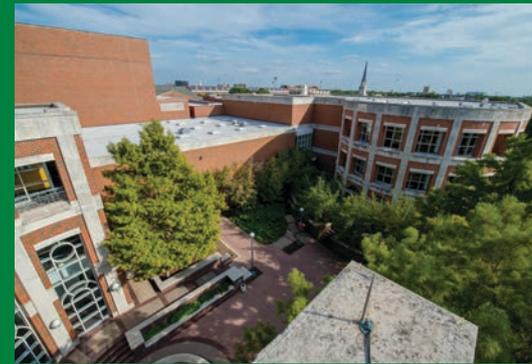
Clockwise from top: Castro Roofing workers remove an existing coal-tar pitch roof system from a 102,600-square-foot area; a worker lays new polyisocyanurate insulation; workers torch new base and cap sheets; an aerial view of one of the new polymer-modified roof systems; a worker installs a new polymer-modified bitumen membrane.

On the wood roof deck, workers installed new underlayment and GAF Slateline® Shingles.

On the lightweight concrete areas, workers installed a new SOPREMA® polymer-modified bitumen roof system composed of a mechanically attached base sheet, a torched base sheet and a torched cap sheet.

On the structural concrete and metal decks, workers installed a new SOPREMA polymer-modified bitumen roof system composed of mechanically attached polyisocyanurate insulation, SOPRABOARD, a torched base sheet and a torched cap sheet.
