ARTFULLY EXECUTED ROOFING

CASTRO ROOFING RENOVATES MULTIPLE ROOF SYSTEMS ON THE OWEN ARTS CENTER IN DALLAS

During 2014-15, the Owen Arts Center's 107,900-square-foot roof with multiple roof systems underwent renovations by Castro Roofing of Texas, Dallas.

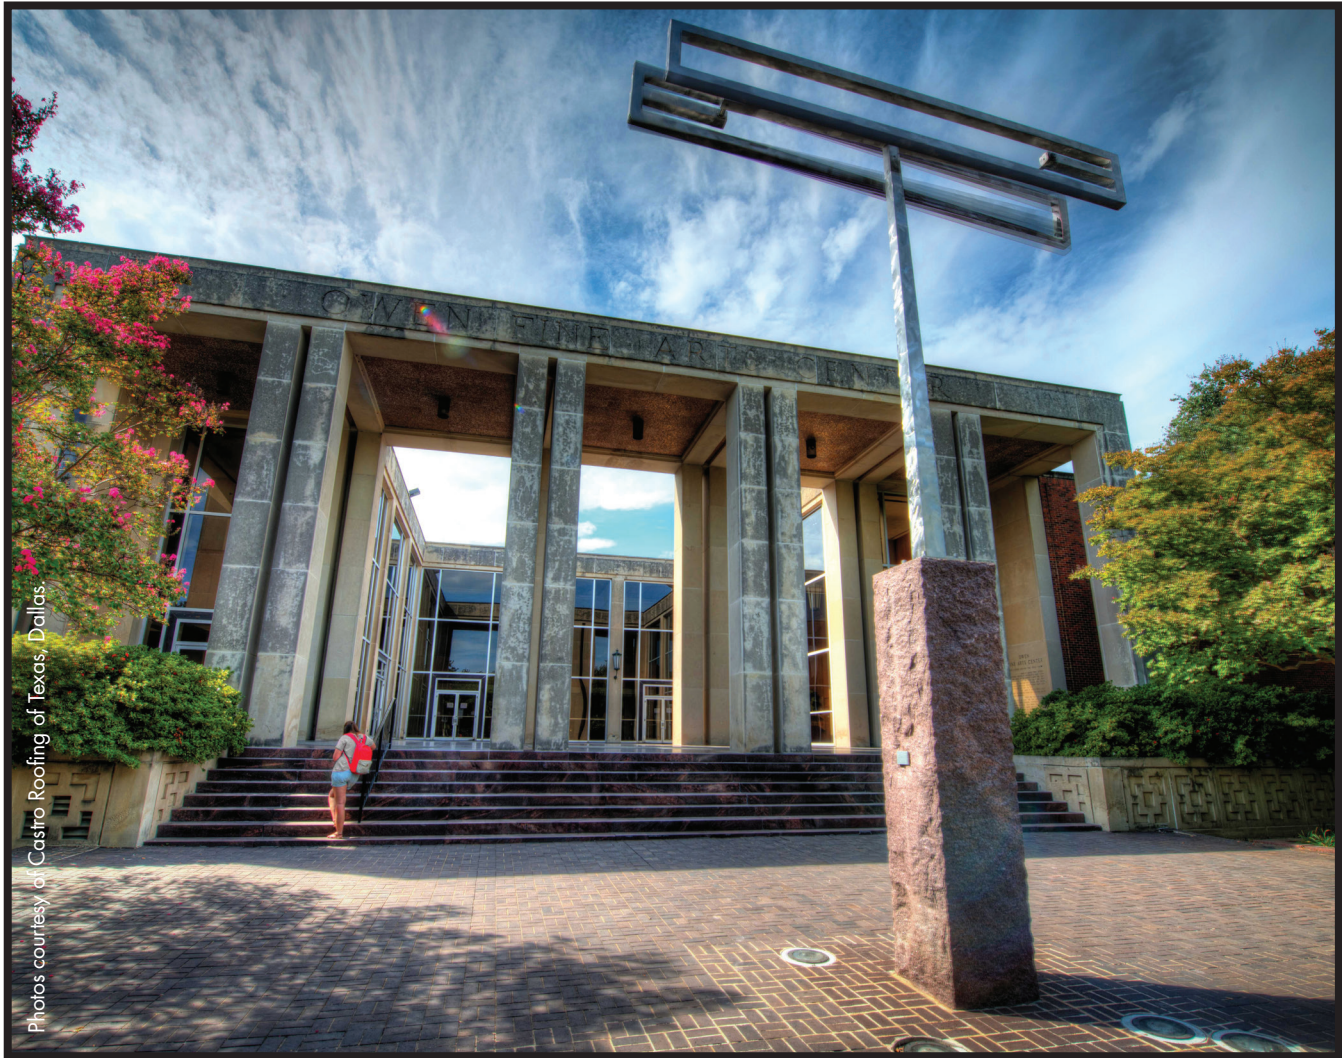
On a 5,300-square-foot roof area, workers tore off composition shingles down to a structural wood deck. On a 102,600-square-foot roof area, workers removed the existing polymer-modified bitumen and coal-tar pitch roof systems down to several decks consisting of lightweight insulating concrete, structural concrete and 22-gauge metal.

As a result of improper installation and leak repairs to the coal-tar pitch, including the use of asphaltic materials and leaving felts exposed to the sun, the coal-tar pitch roof system failed prematurely.

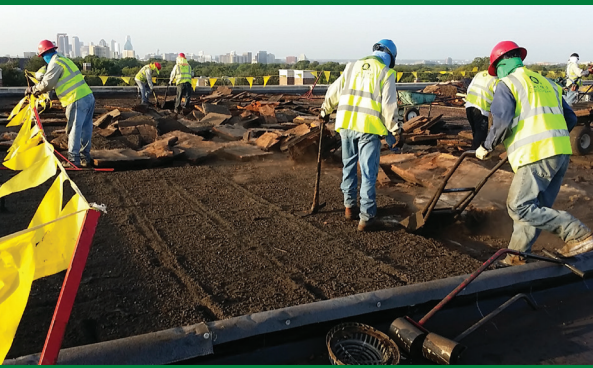
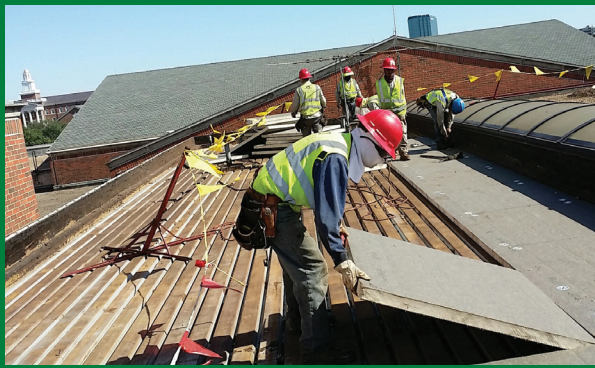
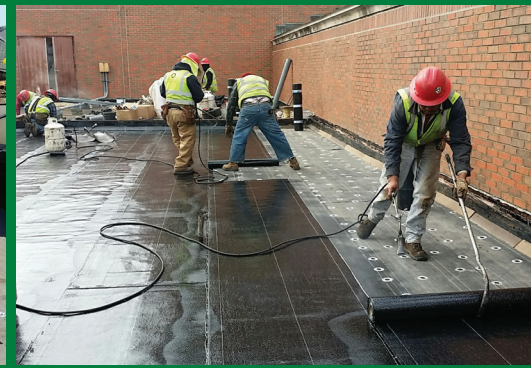
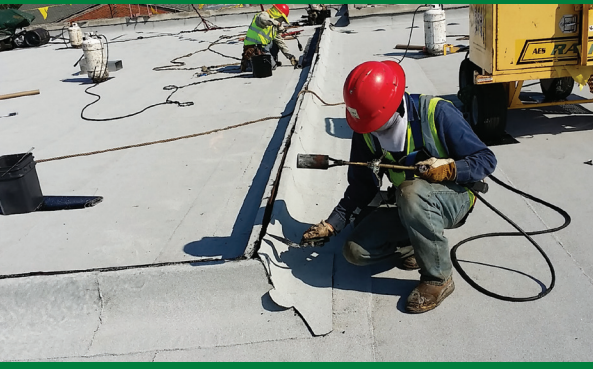
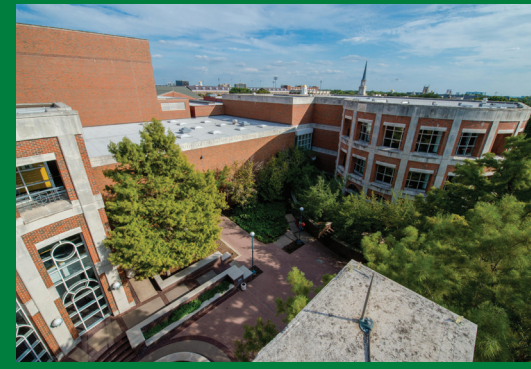
Clockwise from top: Castro Roofing workers remove an existing coal-tar pitch roof system from a 102,600-square-foot area; a worker lays new polyisocyanurate insulation; workers torch new base and cap sheets; an aerial view of one of the new polymer-modified roof systems; a worker installs a new polymer-modified bitumen membrane.

On the lightweight concrete areas, workers installed a new SOPREMA® polymer-modified bitumen roof system composed of a mechanically attached base sheet, a torched base sheet and a torched cap sheet.

On the structural concrete and metal decks, workers installed a new SOPREMA polymer-modified bitumen roof system composed of mechanically attached polyisocyanurate insulation, SOPRABOARD, a torched base sheet and a torched cap sheet.
