2016 GOLD CIRCLE AWARDS ENTRY

CASTRO ROOFING'S MASTERPIECE  
SMU OWEN ARTS CENTER

Official project name: *SMU Owens Arts Center*

Modified Bitumen Roof System

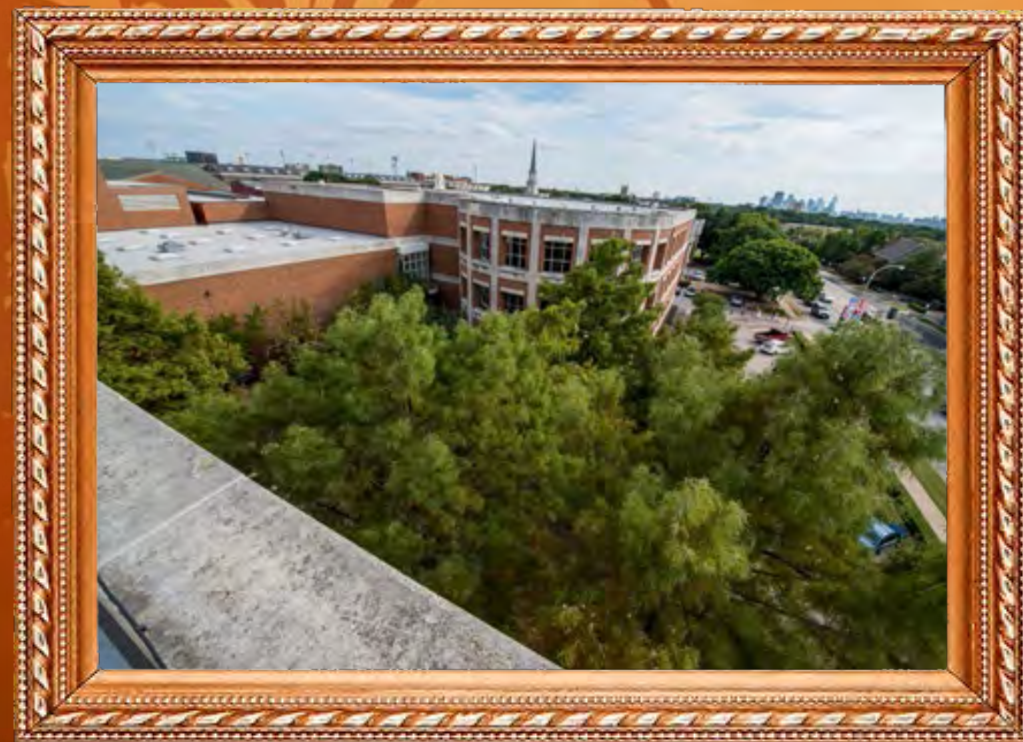
The staging area was limited to one location of 400 sq. ft. to roof 107,900 sq. ft. This presented logistical difficulties because of the traffic in and around the area. Of particular difficulty was removing full dumpsters and replacing the empty dumpsters. In some instances the dumpster company just wanted to leave without performing the dumpster swap-out because of the patience required to accomplish. We also had difficulty with professors and students attempting to enter restricted areas even though they were clearly marked. Special safety precautions were taken for the well-being of all pedestrians walking near the construction site.

*Impossible staging area*

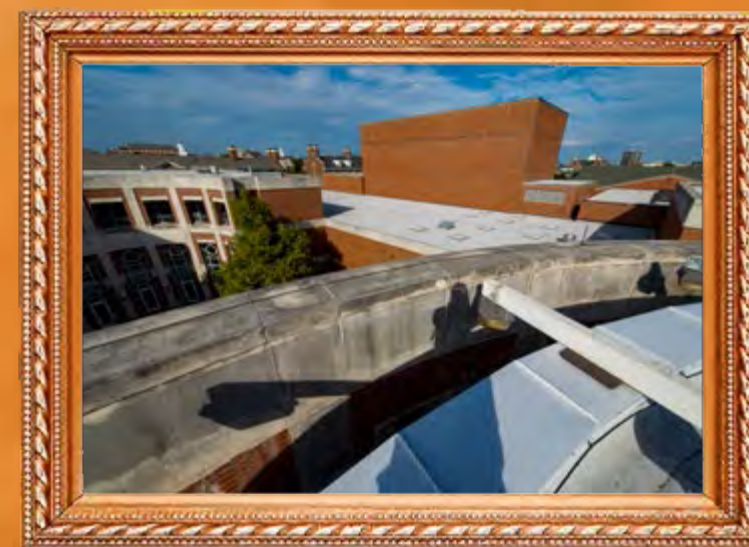
*18 different roof elevations*

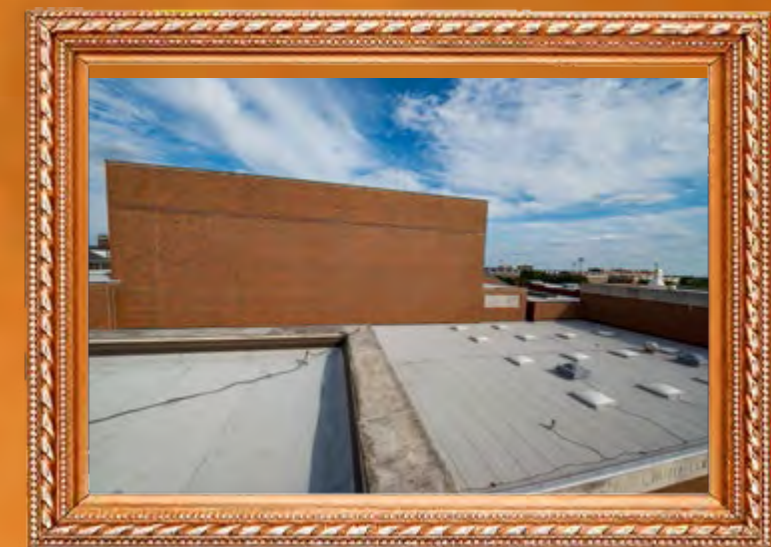
*High roof was done using manual labor,  
no mechanical equipment was used.*

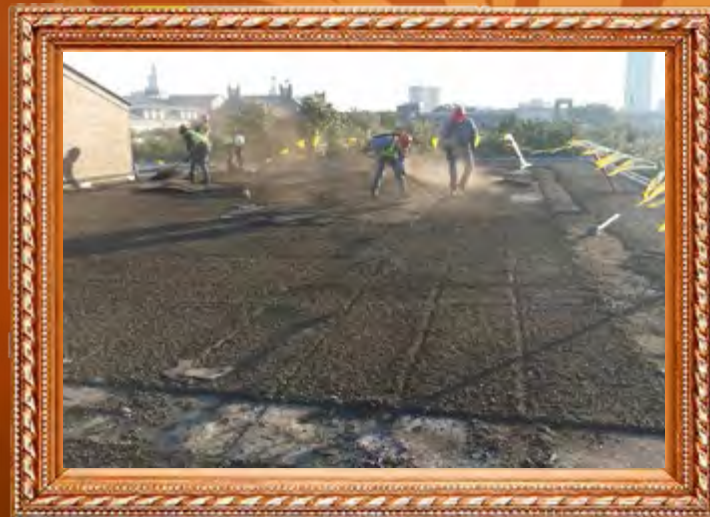
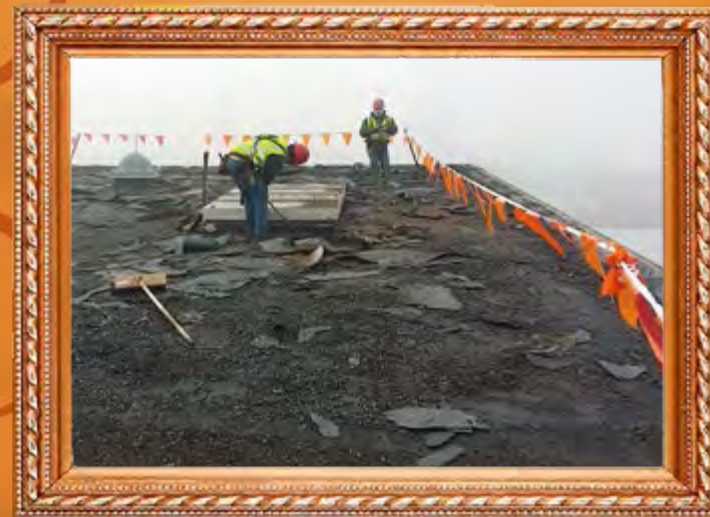
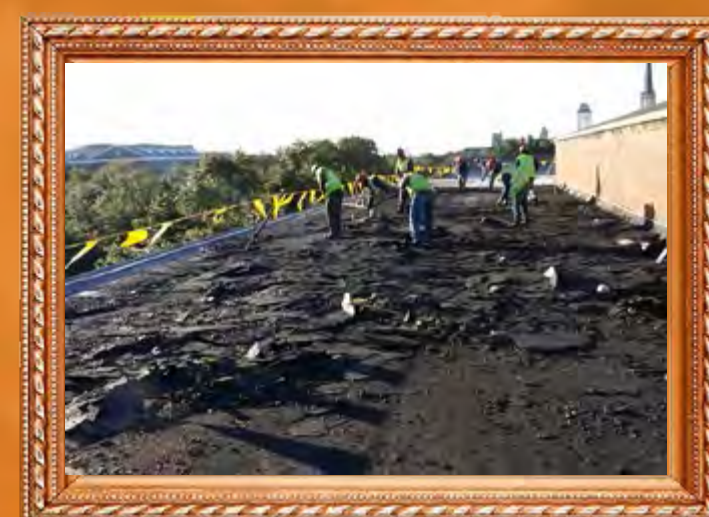
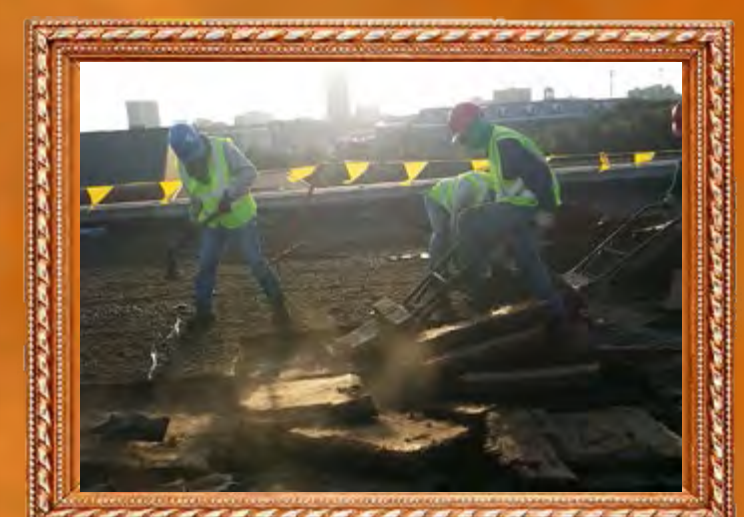
The existing roof system consisted of multiple coal-tar pitch with a flood coat and gravel surfacing. Coal-tar roof systems are particularly difficult to remove in re-roofing projects such as this project. The coal-tar has a low softening point which causes the pitch to “run” in hot weather. Therefore, no demolition can realistically occur during hot days because the pitch turns into a “gooey” mess. Another aspect is that as the pitch roof system is removed it generates airborne particles that are irritating to the skin and specially so if there is sweat present. Special safety gear is worn to protect from this irritant. The above coupled with the logistics of the many multiple roof areas and the need to double and triple handle the debris made for a very difficult tear-off scenario.

Because this roof system’s adhesive, the coal-tar itself, has a low softening point, it tends to soften and “melt” during hot weather. Therefore, the lightning protection cables dug into the pitch flood coat and was actually surrounded by the pitch. Every cable was carefully removed one by one and then meticulously cleaned to remove the coal-tar for reapplication once the new roof system was made ready to receive the lightning protection.

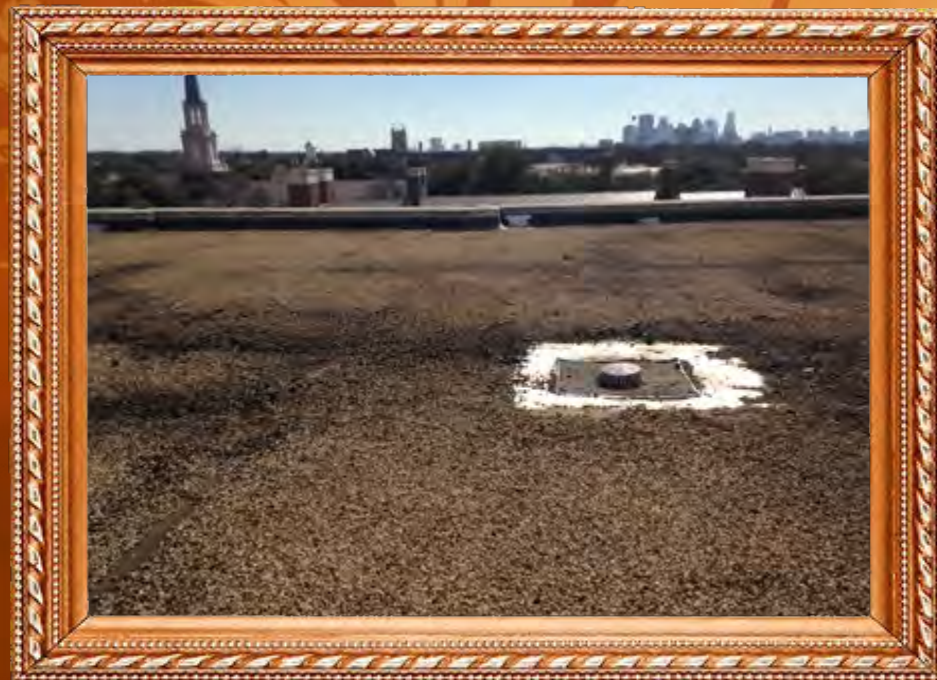
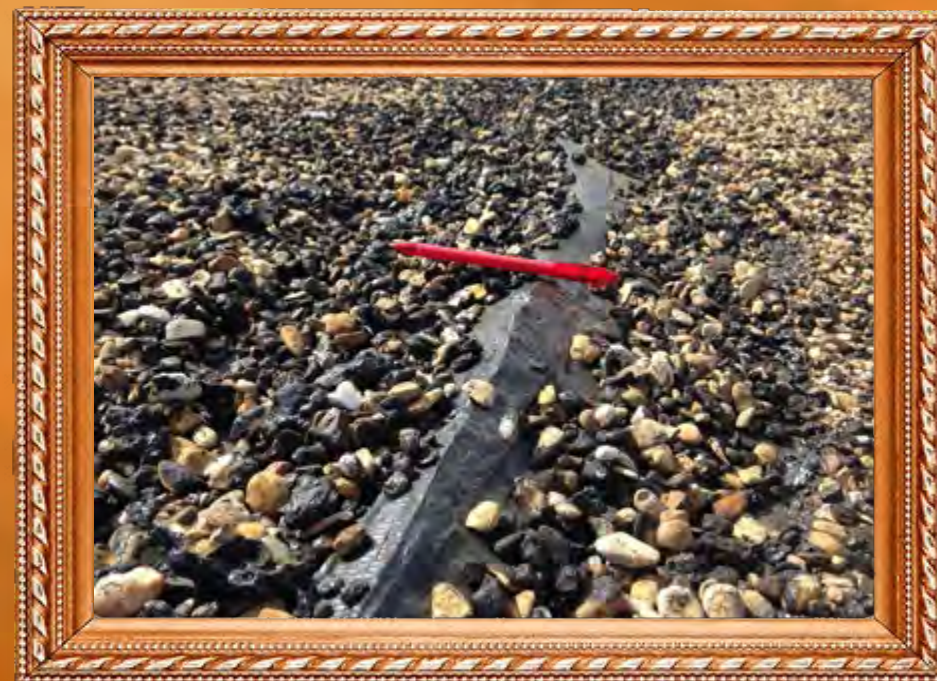
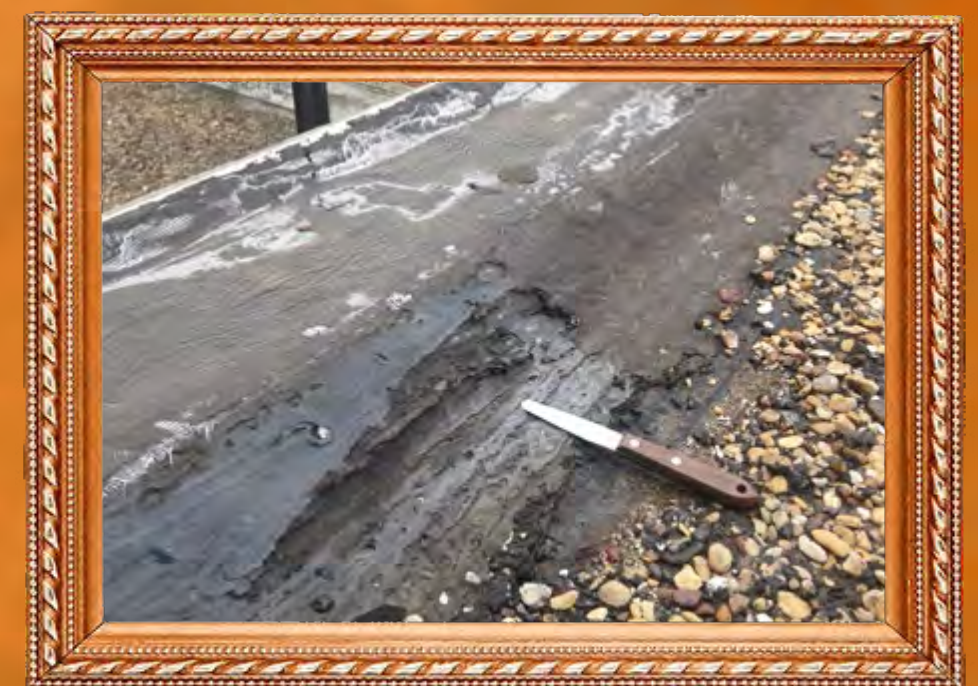
Coal Tar built-up roofing systems are considered the Mercedes of commercial roofing systems. The Coal Tar Pitch roof at Owen Art Center still had plenty of life left, but due to leak repairs being done incorrectly by other roofing contractors (using asphalt materials, leaving the felts exposed to the sun and not repairing the roof leaks) throughout its history caused the roof to fail prematurely.

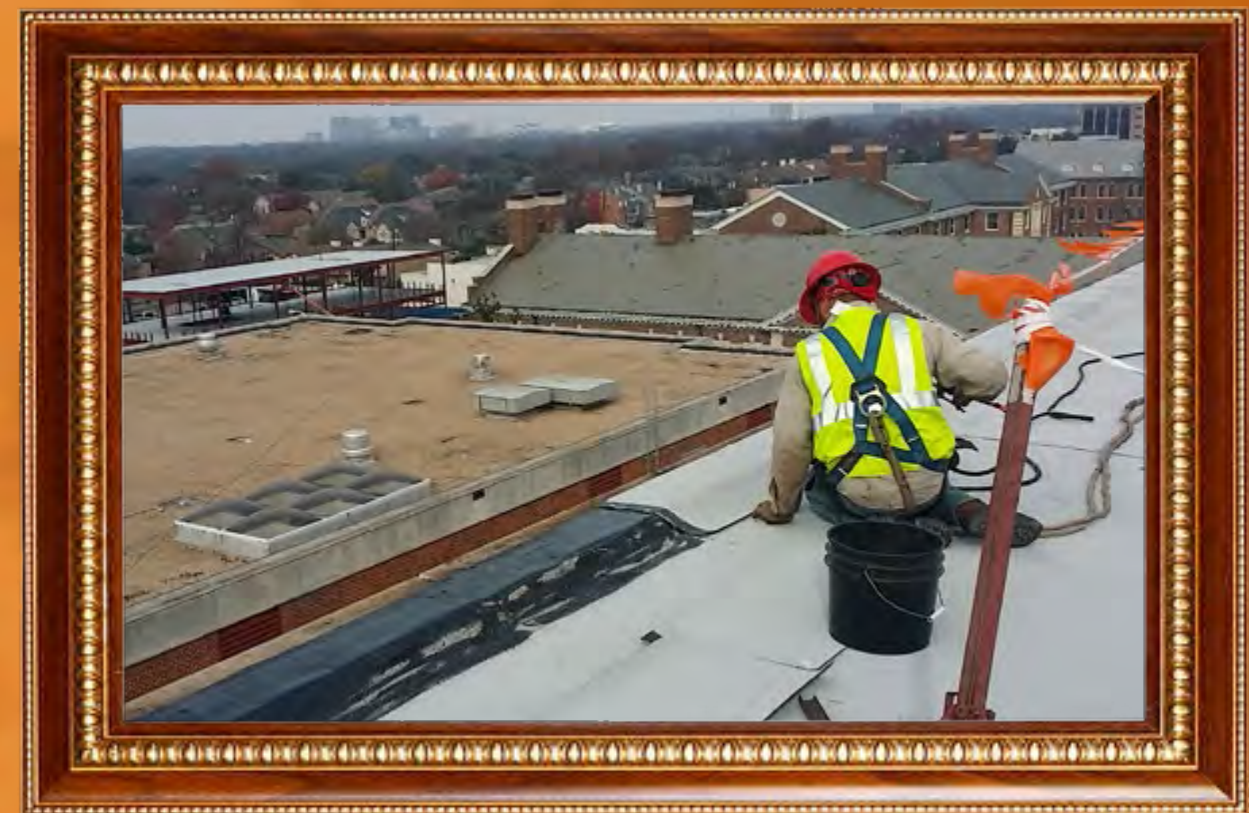
*100% Tied-off*
